This inspection is on a 1 story single family residence, brick, cement fiber board, and wood exterior, composition roof with attached garage. This property faces north.

PROPERTY INSPECTION REPORT

Concerning: 123 Main St., Houston, TX 77095
(Address or Other Identification of Inspected Property)

By: Micah Stephens, Lic #22271 11/01/2017
(Name and License Number of Inspector) (Date)

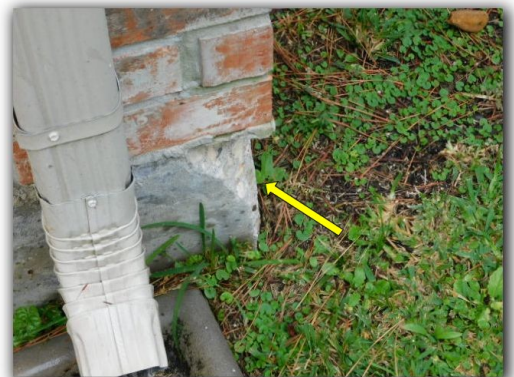
Cracking across the corners of the foundation known as “Spalling” was observed in several areas at the time of inspection. This condition is not normally a structural concern. However, cracks should be sealed to avoid possible water or insect infiltration; northeast and northwest corner.

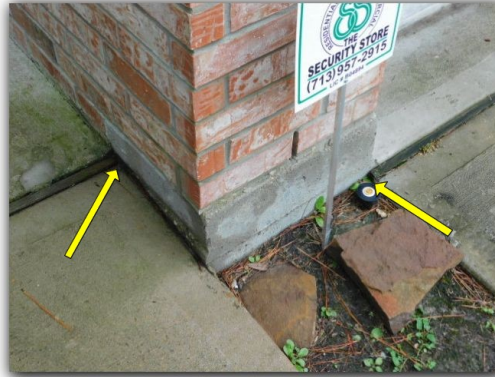
Wood was observed against the foundation wall. This is a condition that is conducive to attracting wood destroying insects. All wood against the foundation should be removed if practicable without damaging surrounding concrete; north side.

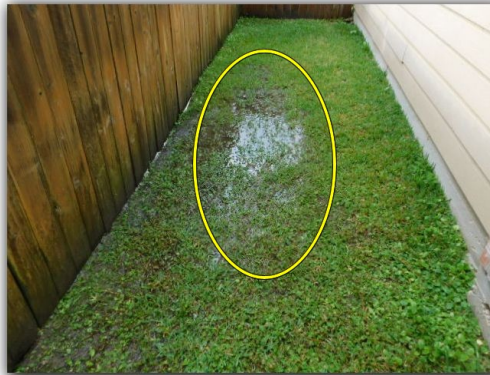
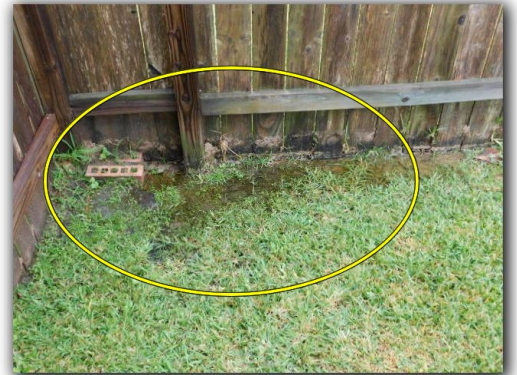
Grading and drainage patterns around some areas of the house do not appear to properly direct water away from the foundation or provide adequate foundation exposure.

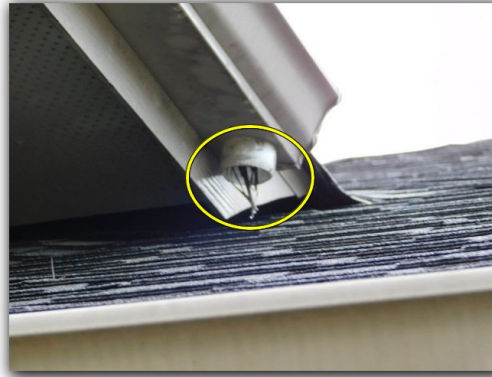
Gutters need general maintenance. Maintenance may include one or more of the following: removal of debris, securing to fascia boards, sealing leaks, securing down spouts, replacing missing splash blocks, sections of gutters, and/or down spouts.

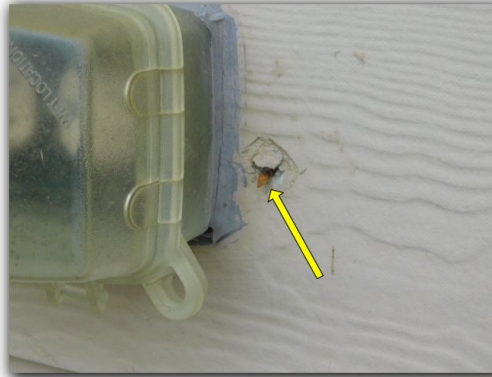
Observed damage to the siding that is caused by something other than moisture; south side.

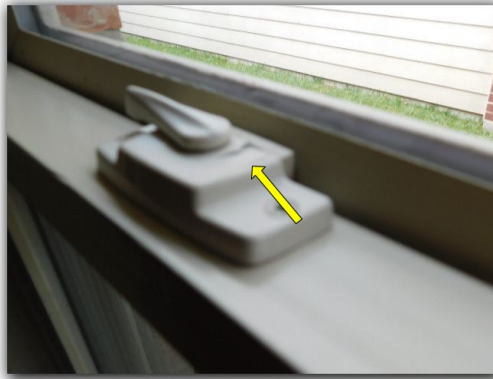
Observed in the southwest bedroom that one latch was broken and the other latch would not lock.

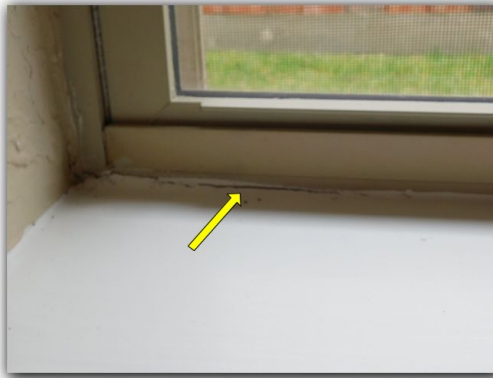
Observed one or more windows with deteriorating or missing caulk.

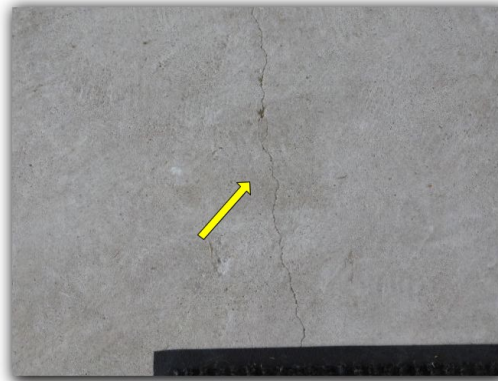
Observed cracks in the slab in the garage.

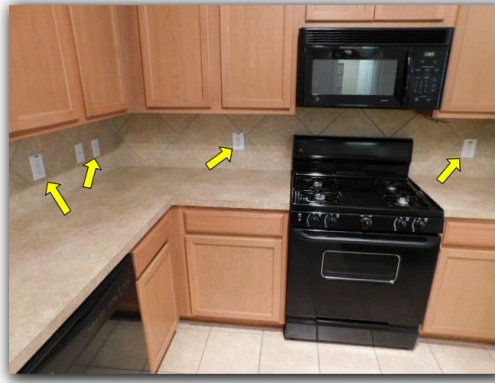
Observed at least one GFCI unit that is not functioning as intended; kitchen.

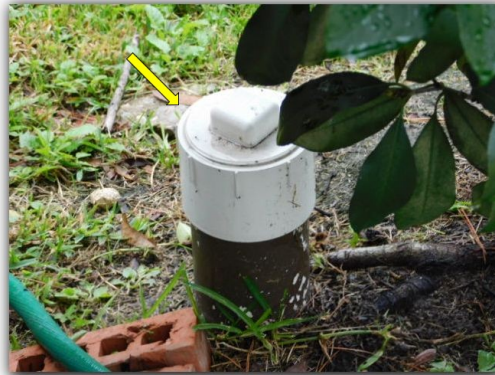
All exterior plastic (PVC) pipes that are exposed to ultra violet rays of the sun light should be painted to prevent damage.

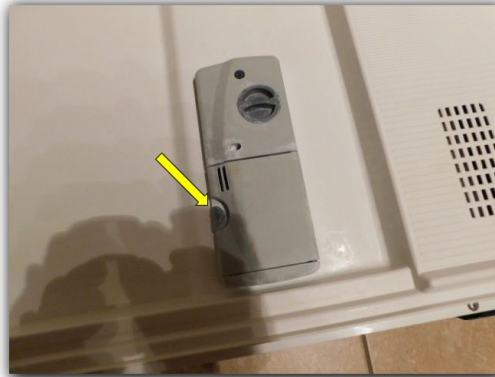
Observed what appeared to be hard water residue on the soap door latch that was restricting the functionality of the door.

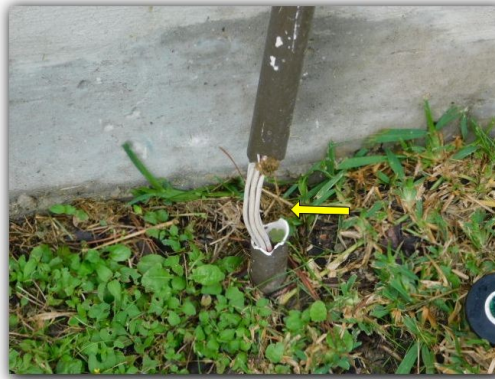
Observed at the time of this inspection could not operate the system by manual controls from the control panel.

Observed the PVC to the control panel from the exterior is broken.
